Health Assessment and Retro-fitting of RCC Structures

This is a report on 'condition assessment of existing RCC structure of NPK-Bulk go-down at Zuari Agro Chemicals Limited, Goa, by using non-destructive/partially-destructive testing, visual inspection survey and laboratory testing of concrete.

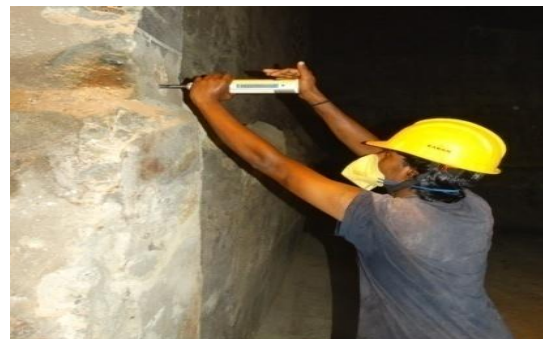
Figure 1: Rebound Hammer in Progress

The rebound hammer test is based on the principle that a calibrated standard mass rebounds off a hard surface in repeatable manner if impacted with standard force. The rebound hammer index or number is considered to be an indicator of the quality of cover concrete. This test is also useful in comparing the quality of concrete from one location to another indicating the homogeneity of the concrete in the structure. Normally it is not very accurate in predicting the compressive strength, but taken together with the more definitive test of core samples, the rebound hammer result can be an indicator of the compressive strength. The rebound hammer test using a standard Schmidt Hammer from M/s CNS FARNEL- England as per IS: 13311 - (Part - II) - 1992 - (Reaffirmed in 2004), was carried out on select RCC members of the building. Fig.1 shows the Rebound Hammer test in progress. A minimum of eight readings were recorded from each location and the average was calculated after omitting the very low and very high readings, if any. The results of the rebound hammer test are tabulated in Table 1. Please refer Fig.11 for identification of test locations.

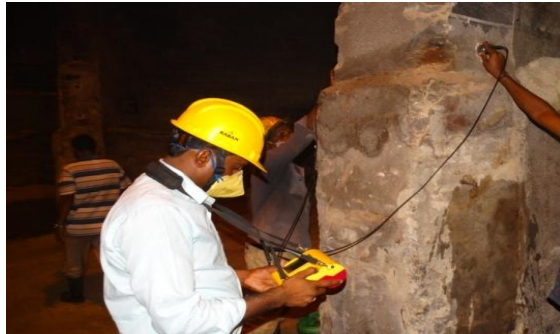
Figure 2: UPV test in Progress

In the present study UPV test was carried out by TICO instrument-Proceq make (Switzerland) as per IS : 13311- (Part - I)-1992- (Reaffirmed in 2004) by Direct and In-direct methods on select RCC members of the structure. Fig.2 shows the UPV test in progress. The results of the UPV test are given in Table-2. Please refer Fig.11 for identification of test locations.

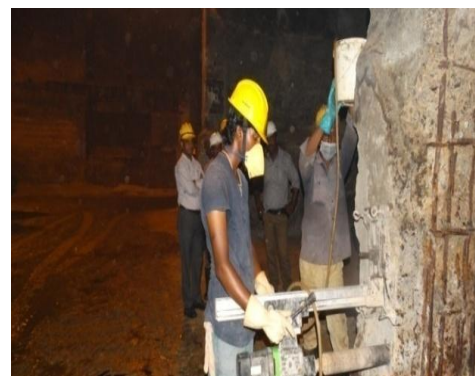
Figure 3: Core Extraction in Progress

Core samples from existing concrete members can be conveniently collected by use of suitable cylindrical drill-bits and tested for compressive strength and other properties. These provide more reliable results of concrete properties in the structures. The Krafeek instrument (German Make), used for the present study was having rotary cutting tool with diamond tip. Core samples of 70 and 110 mm diameter and 100 mm length (approx.) were obtained from various locations for not only compressive strength testing in the laboratory, but also for RCPT, carbonation test and chemical analysis of concrete. Fig.3 shows the concrete core extraction in progress and Fig.4 shows the core samples obtained. Please refer Fig.11 for identification of test locations.

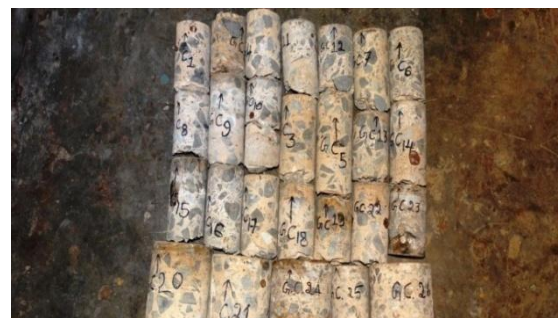
Figure 4: Concrete Core Samples

The compressive strength as measured from cores gives the best assessment of the concrete strength. The results of tests conducted on cores are given in Table 3.

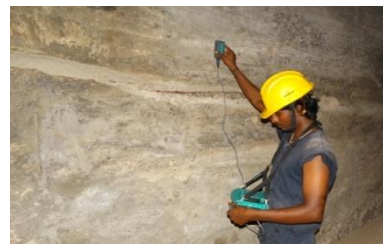
Figure 5: Cover Meter Test in Progress

The concrete cover to the embedded reinforcement steel in the RCC structures can be measured conveniently by using cover meter instruments which work on the principles of magnetism. The cover meter test was performed with the help of Profometer 5+ instrument-Proceq make (Switzerland) at select locations on the structures to find the concrete cover to reinforcement. The criterion used for adequacy of results is as per structure's exposure condition with respect to the minimum cover mentioned in IS:456-2000 (Reaffirmed in 2011). Fig. 5 shows the Cover meter test in progress. The

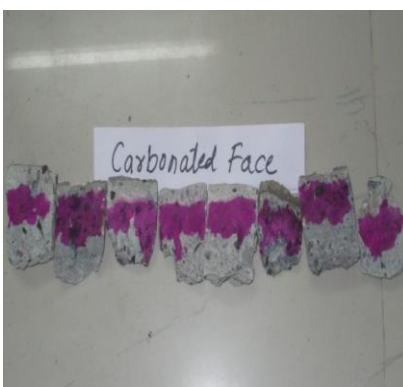
Figure 6: Carbonation test on core samples

The carbonation test was carried out at select locations as per the guidelines given in BS:1881 (Part 201)–1986. Carbonation depths are simply determined by the use of (1% ethanol) indicator after a freshly broken concrete surface is sprayed by phenolphthalein. Depth of carbonation is indicated by the colourlessness of the test zone in concrete sample and pink colour indicates presence of alkaline concrete. Fig.6 shows the carbonation test carried out on concrete sample. The results of carbonation test are tabulated in Table-5. Please refer Fig.11 for identification of test locations.

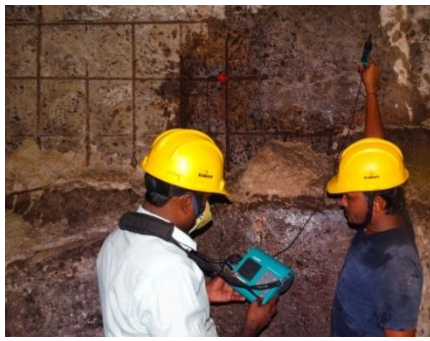
Figure 7: Half-cell Potential Test in Progress

locations on the RCC members of the building. Fig.7 shows the Half-cell potential measurements in progress. The results of the half-cell potential measurements are tabulated in Table-6. Please refer Fig.11 for identification of test locations.

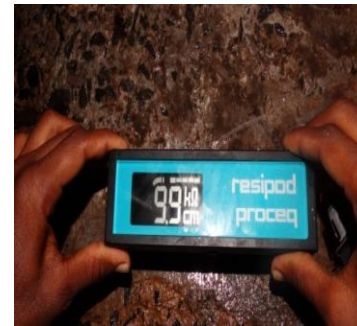
Figure 8: Electrical Resistivity Test in Progress

The electrical resistivity test was performed with the help of Resipod instrument-Proceq make (Switzerland) at select locations on the RCC chimney. Fig.8 shows the electrical resistivity test is in progress. The results of the resistivity test are tabulated in Table-8. Please refer Fig.11 for identification of test locations.

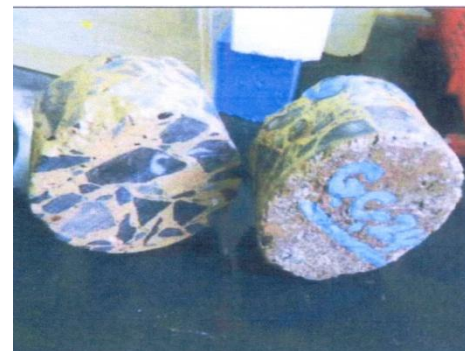
Figure 9: Samples Prepared for RCPT

RCPT was carried out at 25 Degree Celsius in KCPPL, DSIR accredited R&D laboratory, Mahape, Navi-Mumbai. Fig.9 and Fig.10 show the RCPT in progress. The results of the RCPT are tabulated in Table-10. Please refer Fig.11 for identification of test samples.
